Manhole Inspection Summary

Manhole # S35CC_024MH

Insp Date: 11/17/08 12:58 PM

Location Address: **1039 st paul st**

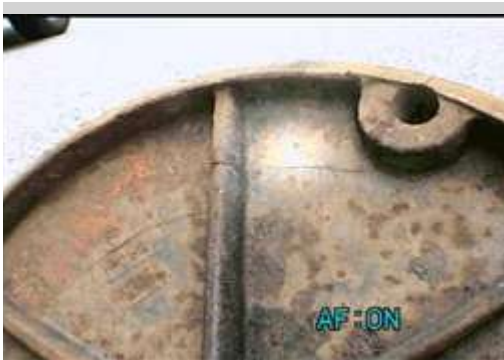
Defect 5

Condition: **Cracked**

bad cracked cover

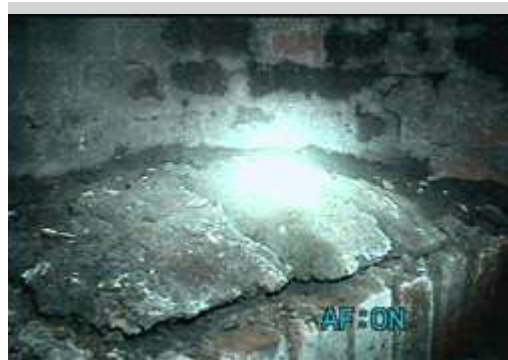
Defect 4

Condition: ☐ Sound ☐ Cracked ☐ Root Intrusion ☐ Deteriorated ☐ Leaks ☒ **Debris**

bench debris

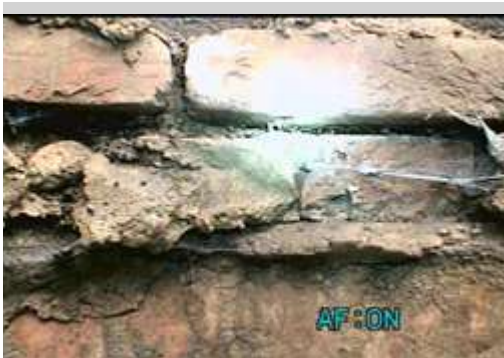
Defect 3

Condition: ☐ Sound ☒ **Cracked** ☐ Root Intrusion ☒ **Loose Brick** ☒ **Deteriorated**

chimney loose bricks and deteriorated,
frame adj

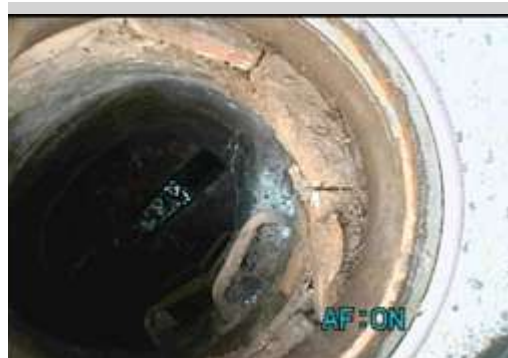
Defect 2

Offset: **3** (in.)

offset

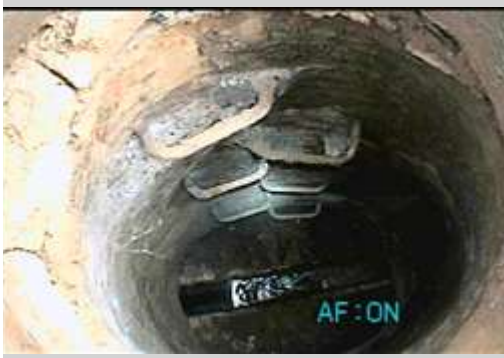
Defect 1

Count: **6** Missing: **0** ☒ **Corroded**

corr steps

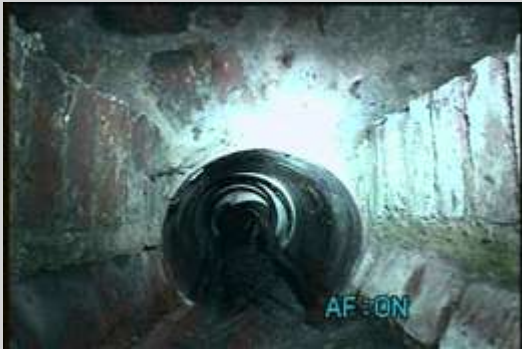
12 O'Clock Outflow

8 in. Circular Gravity Sewer
Pipe Out @ 12 O'Clock

Invert Depth: **10.50** (ft.) Flow Characteristics: **Slow**

Deposits: ☒ None ☐ Mud ☐ Sludge ☐ Debris ☐ Grease

Infiltration: **None** Pipe Seal Cond: **Unknown**

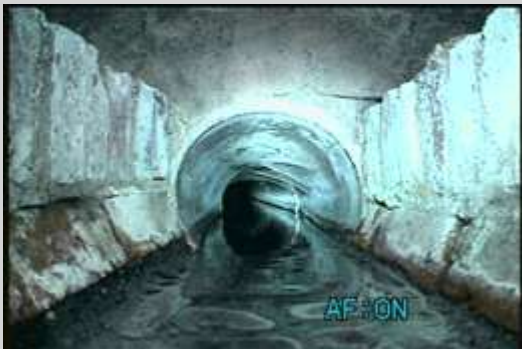
6 O'Clock Inflow

8 in. Circular Gravity Sewer
Pipe In @ 6 O'Clock

Invert Depth: **10.41** (ft.) Flow Characteristics: **Slow**

Deposits: ☒ None ☐ Mud ☐ Sludge ☐ Debris ☐ Grease

Infiltration: **None** Pipe Seal Cond: **Unknown**
